VILLAGE OF BEAVER SITE ASSESSMENT PROJECT REPORT

BEAVER, ALASKA

January 4, 2002

Prepared for the Alaska Department of Environmental Conservation
by

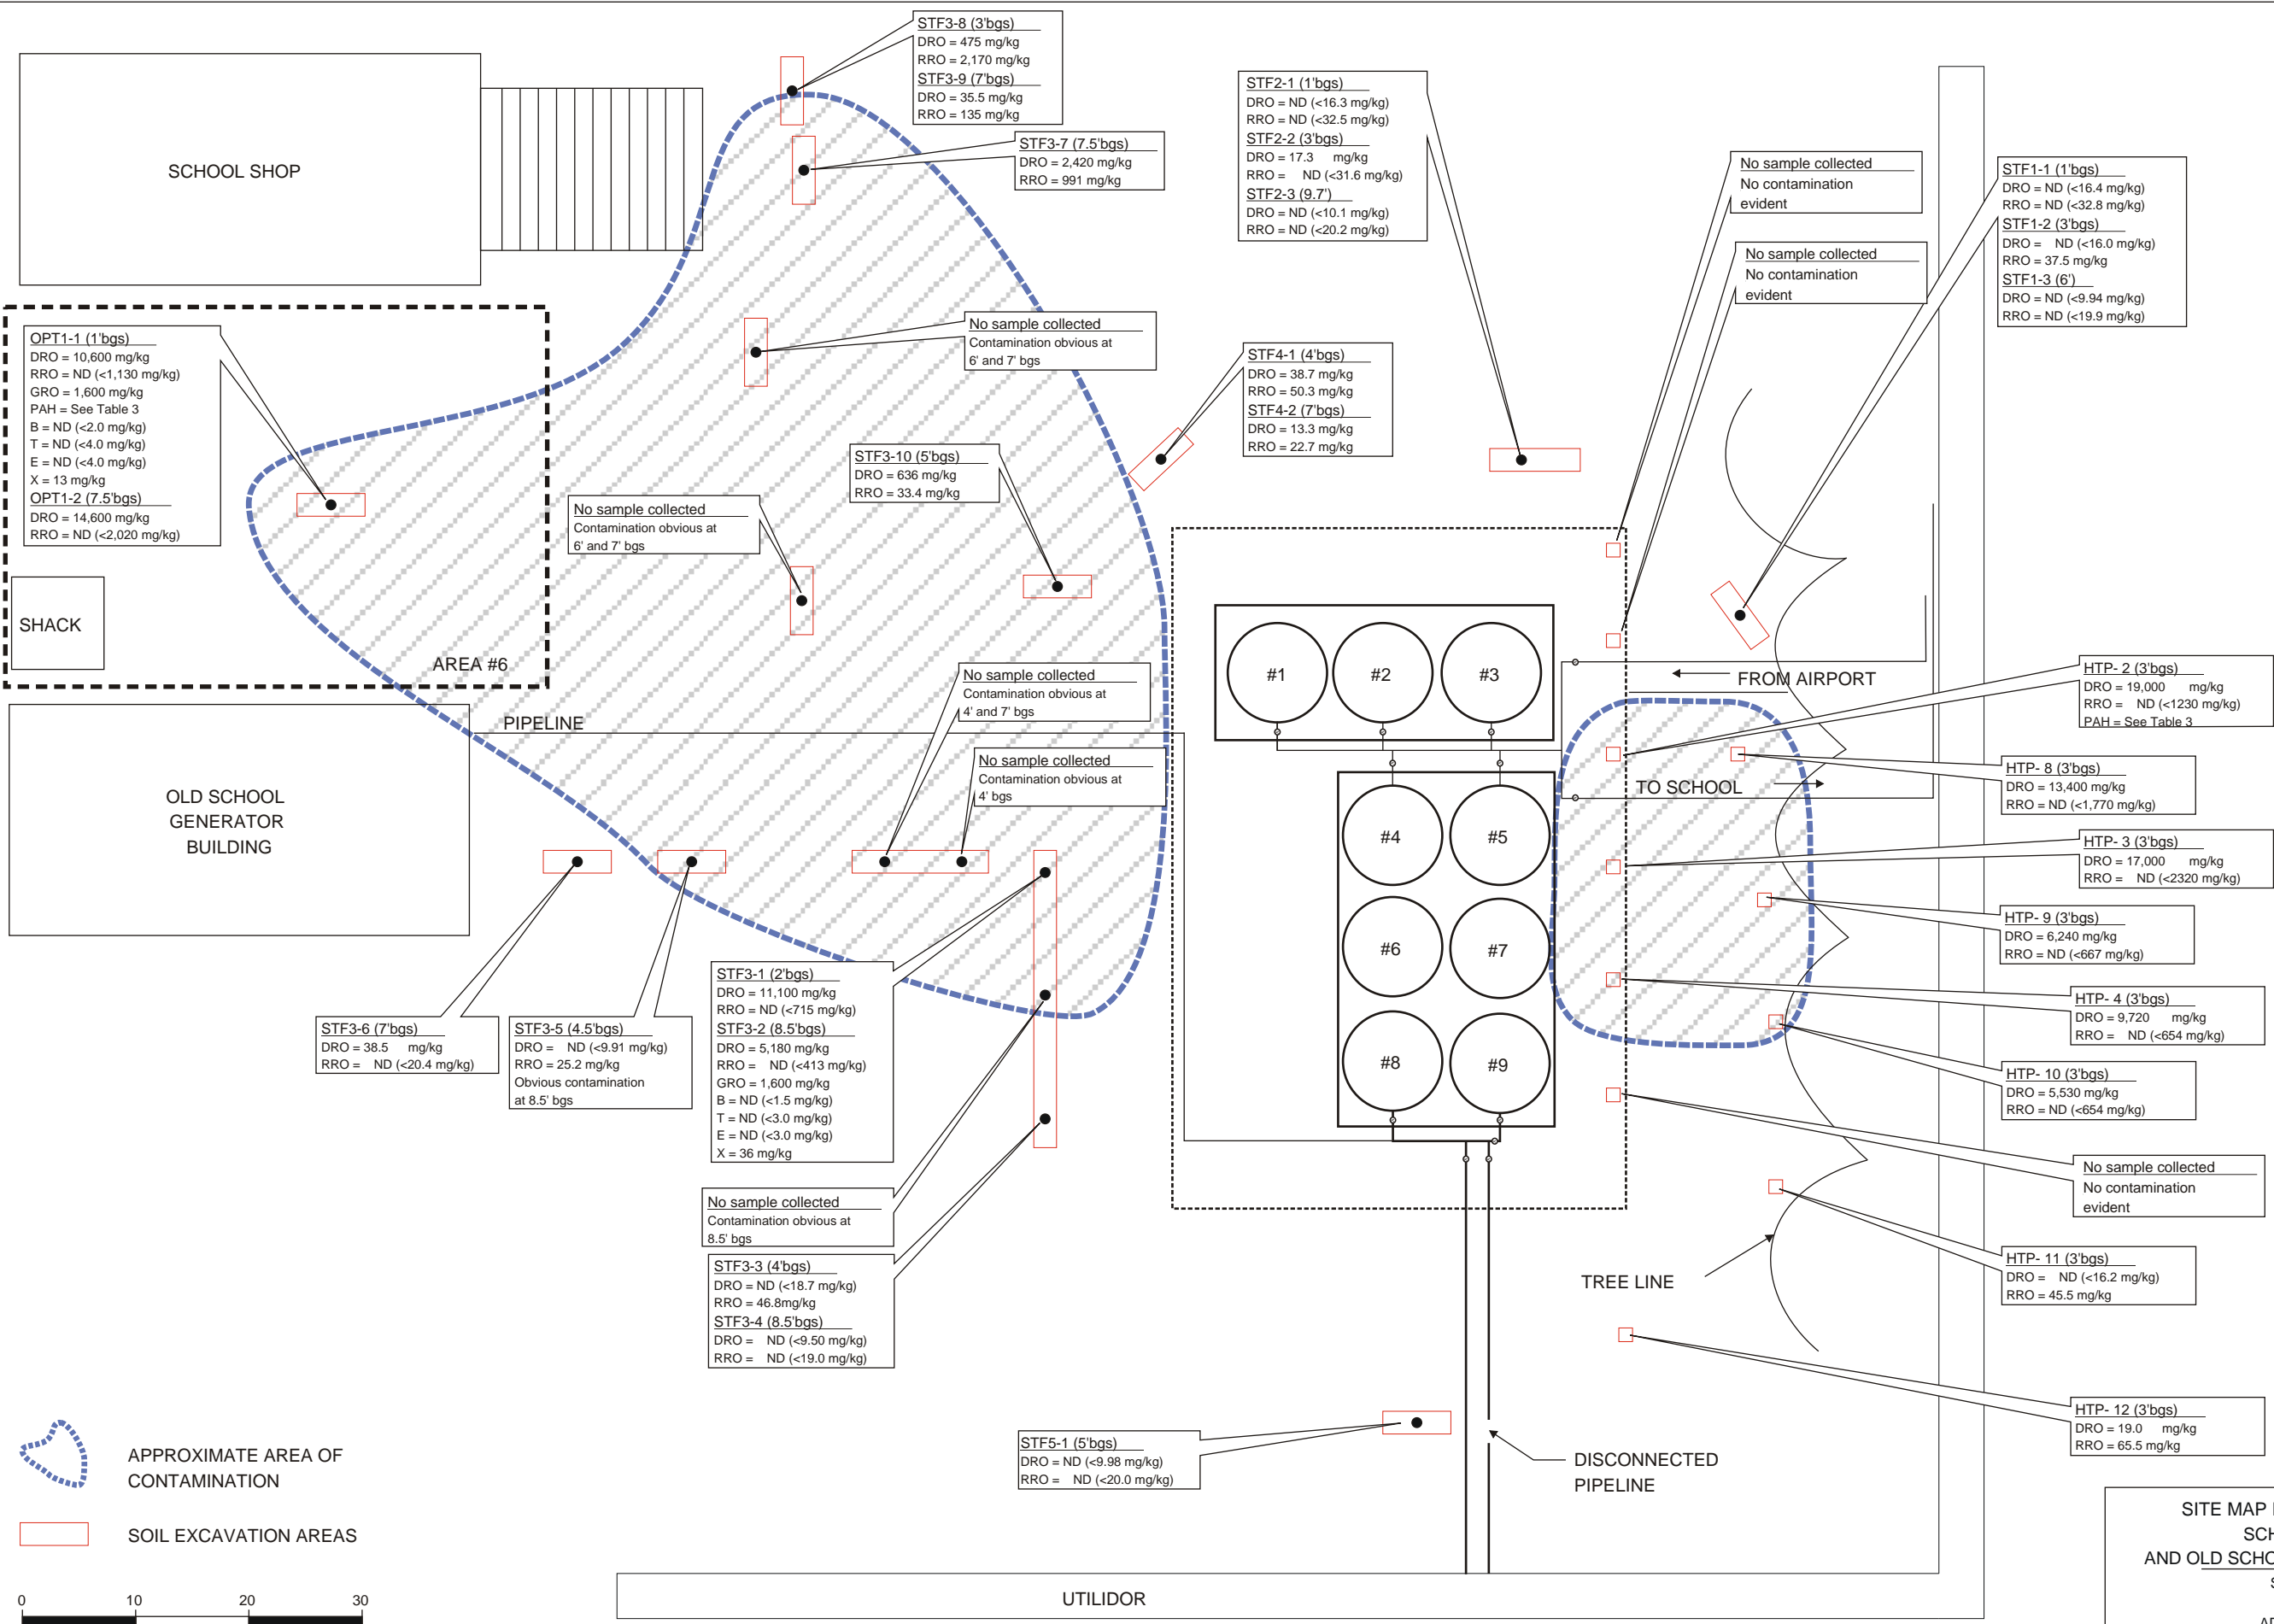
SITE MAP FOR SITES #1 AND #6
SCHOOL TANK FARM
AND OLD SCHOOL GENERATOR HOUSE
SITE ASSESSMENT
BEAVER, ALASKA
ADEC UST PROGRAM

Several valves and fittings on the interconnecting piping within the tank farm appear to have leaked to varying degrees. Tank #2 is fitted, at the bottom on the north side of the tank, with a flexible hose that is used to fill the school shop day tank. When not in use the hose is coiled on the gate of the fence that encloses the tank farm. The tank farm is not lined and does not have secondary containment berms.

With high concentrations of DRO to at least 8.5 feet below ground surface on the west and northwest sides of the tank farm, and at least 3.0 feet below ground surface on the east side of the tank farm, it is possible that contamination has impacted groundwater or intersected permafrost.

DRO concentrations in the soil at the school tank farm site are high enough to pose a hazard to residents by direct contact. The contamination levels also indicate that the soil in the area of the tank farm will act as a continuing source of leachate to groundwater. With the levels of contamination shown to be present to 8.5 feet below ground surface, it is reasonable to expect the contamination to extend vertically to at least 15 feet below ground surface. OASIS recommends soil removal in the contaminated areas to approximately 15 feet below ground surface. At that point, contamination remaining at the bottom of the excavation should be documented. A down gradient monitoring well should then be installed to identify migration of contamination to groundwater, if present. Using information obtained from the activities mentioned above, a decision could be made regarding necessity of an in situ remediation system.

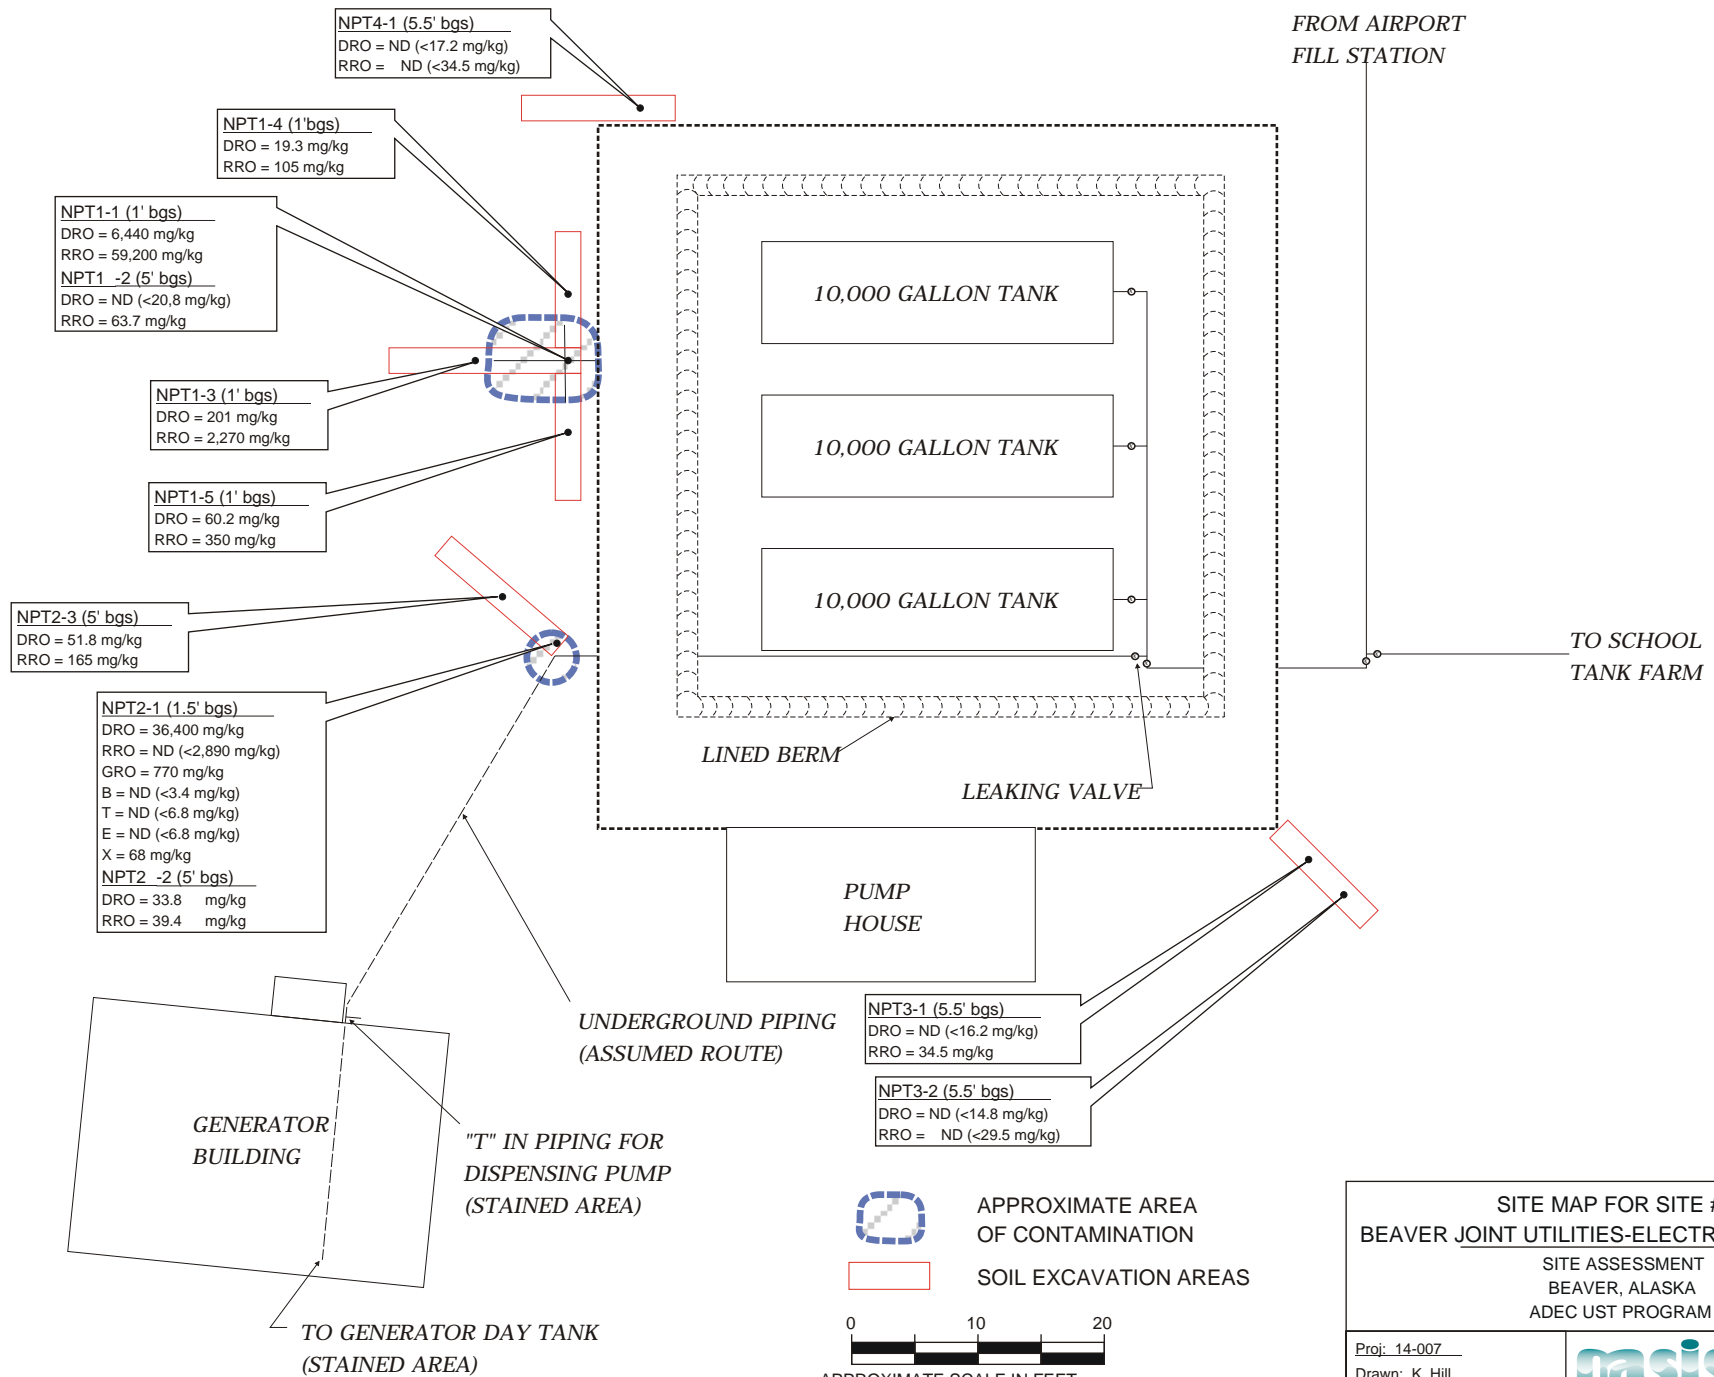
SITE MAP FOR SITE #2
BEAVER JOINT UTILITIES-ELECTRIC PLANT
SITE ASSESSMENT
BEAVER, ALASKA
ADEC UST PROGRAM

The bottom of the containment area for the BJU-E tank farm is covered with grass, and also has standing water with sheen present. An obvious, dripping leak was present from the valve in the piping leading from the southernmost of the tanks.

The area around the pump used to fill containers brought by residents was heavily stained in an area about 3 feet in diameter. An adjacent area, approximately 4.5 feet by 7 feet, was also heavily stained due to a leaking pipe joint in the piping from the tank farm to the generator day tank, where the piping goes beneath the generator building. Staining was also present on the south side of the building where the same piping penetrates the generator room floor to connect to the generator day tank. A leaking piping joint on the west side of the tank farm, where the piping exits the tank farm to serve the generator building, also produced heavy staining in an area approximately 4 feet in diameter. At this location, the piping enters the ground surface and is buried until it reaches the generator building.

A dark, stained soil area exists on the west side of the tank farm fence about mid-way up the fence line. Residents indicated that this was an area where used oil was previously stored in 55-gallon drums.

Based on the localized contamination encountered at each of the two test pits mentioned above, OASIS recommends removing the contaminated soil at the NPT1 and NPT2 locations by excavating. OASIS estimates an approximate removal volume of 4 cubic yards of contaminated soil from the two areas combined.

OASIS also recommends that all threaded piping from the tank farm at the BJU-E tank farm be replaced with welded piping.

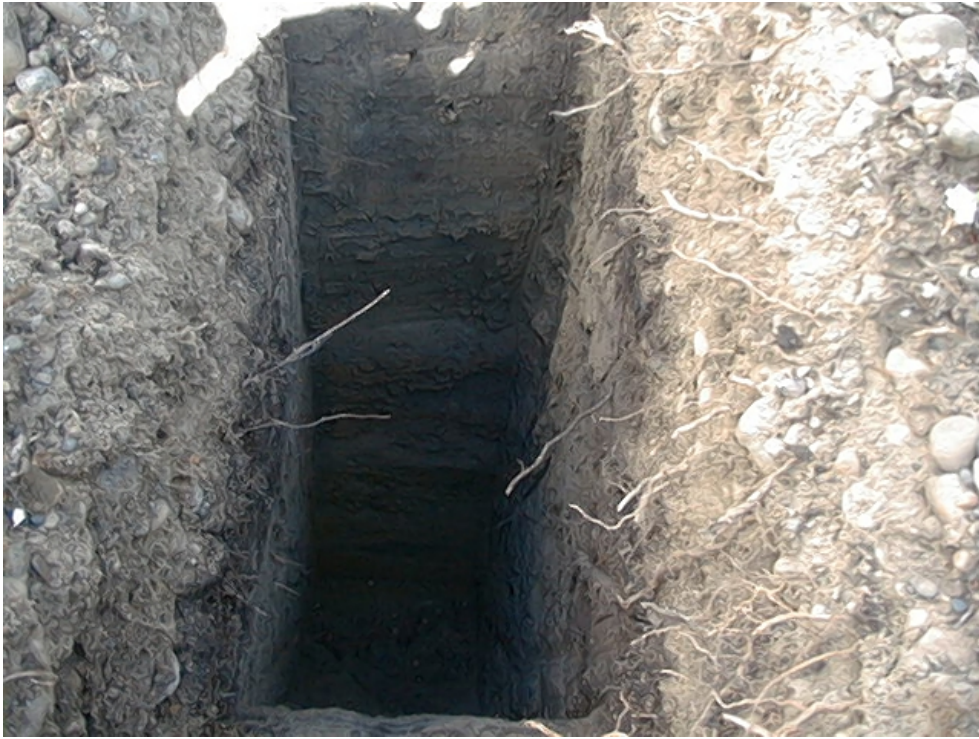
Photo # 38: Hand-dug sample test pit at School Tank Farm.

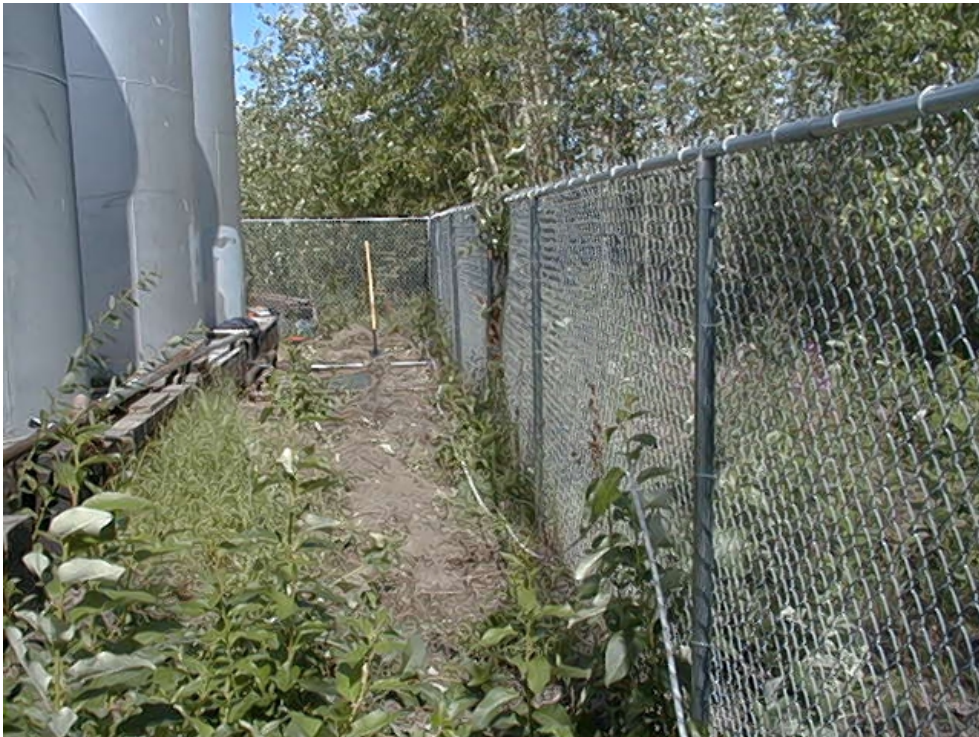
Photo # 40: Hand-dug sample test pits on east end of School Tank Farm..

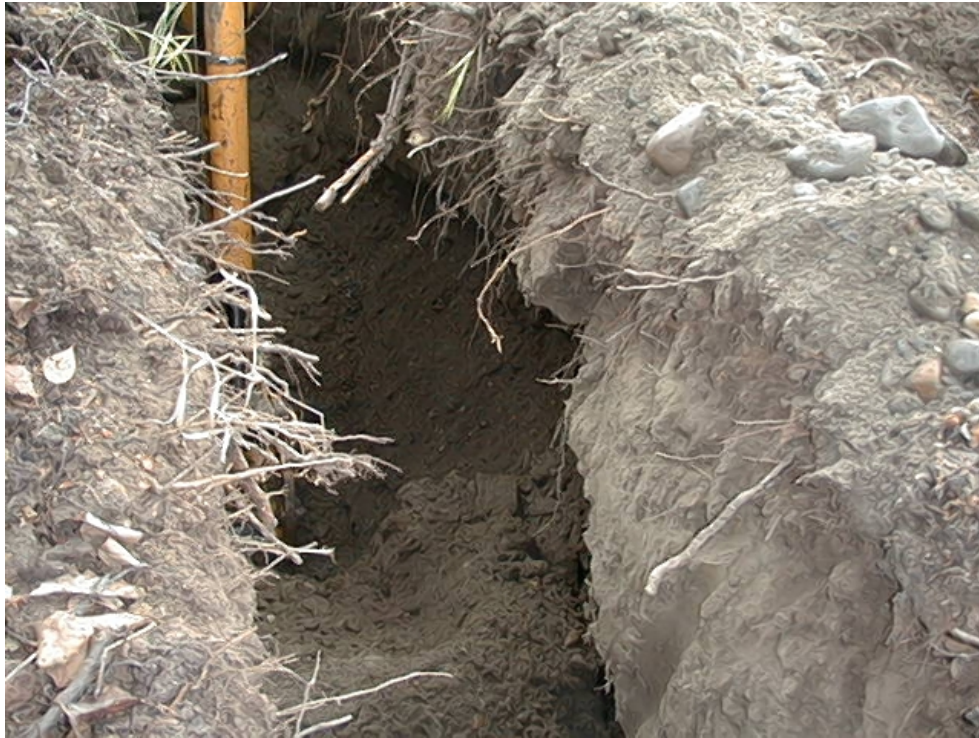
*Photo # 95: Approximately 6 feet below ground surface
in STF3*

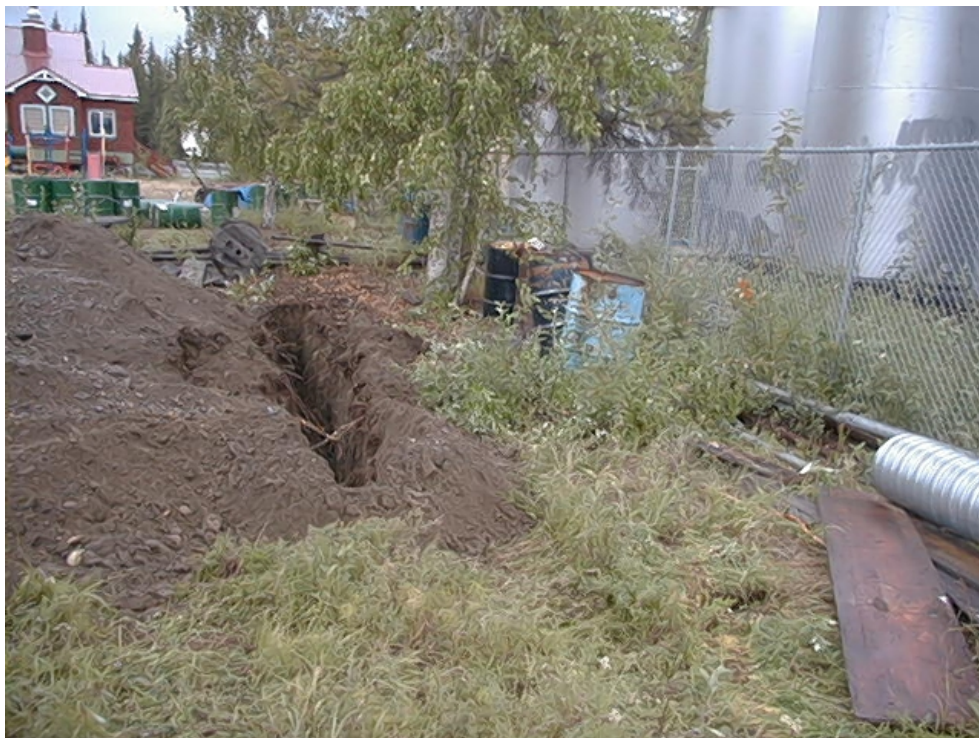
*Photo # 97: Excavation on west end of School
Tank Farm (STF3).*

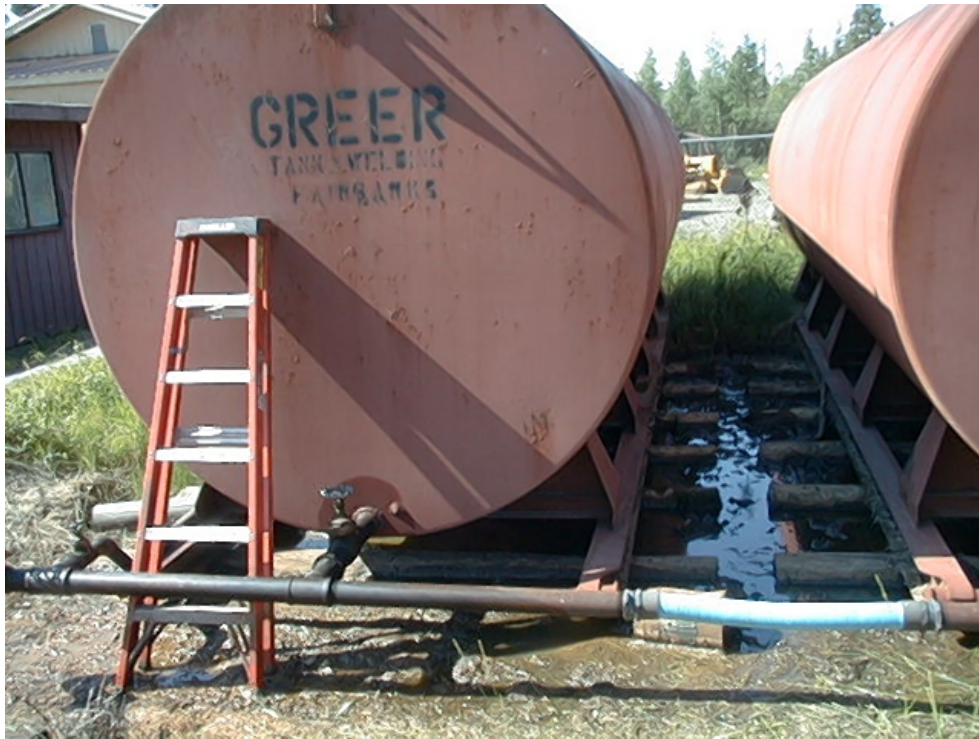
Photo # 22: New Generator Building Tank Farm.

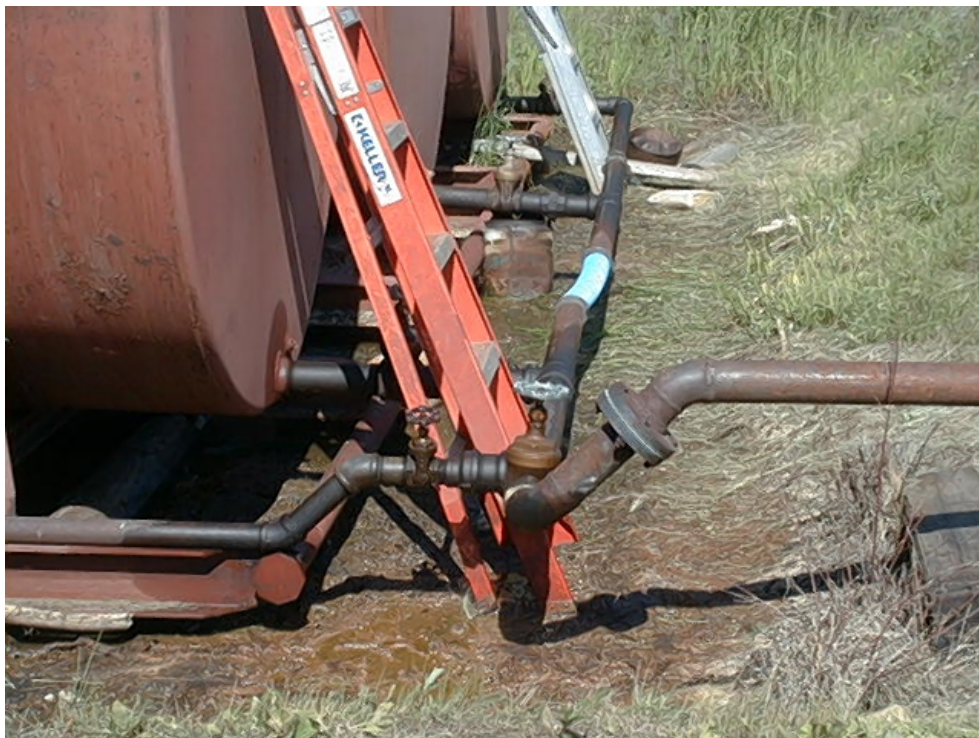
Photo # 21: Leaking pipe fittings at New Generator Building Tank Farm.

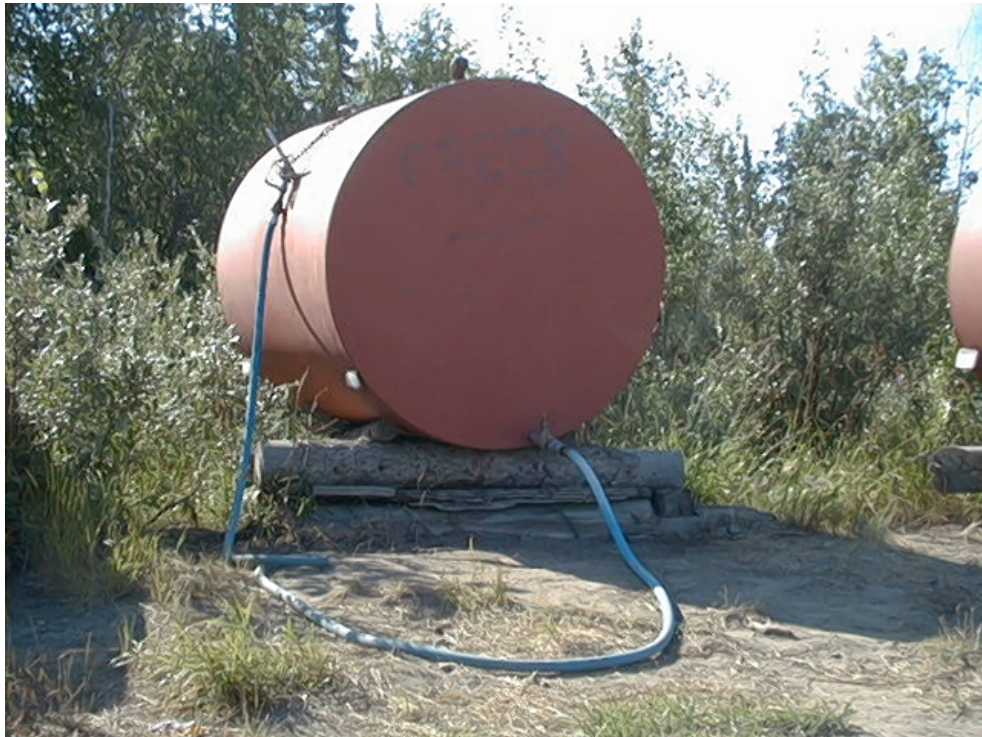
Photo # 13: 1000 gallon Gasoline Tank at Airport.

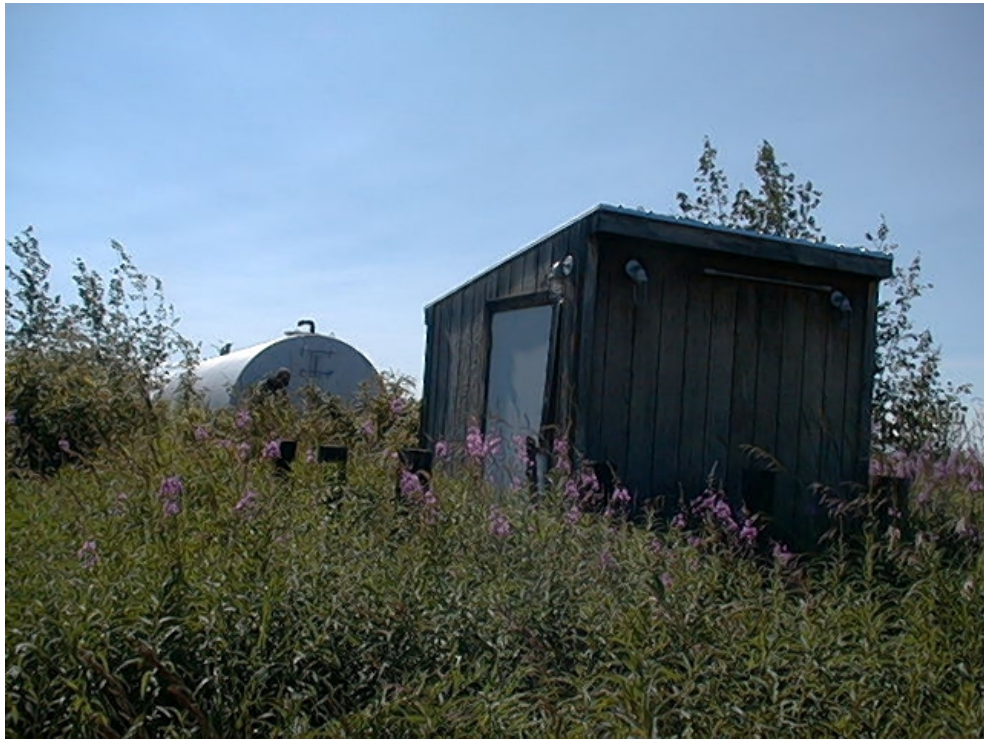
*Photo # 24: 10,000 gal. abandoned storage tank
pumping shed.*

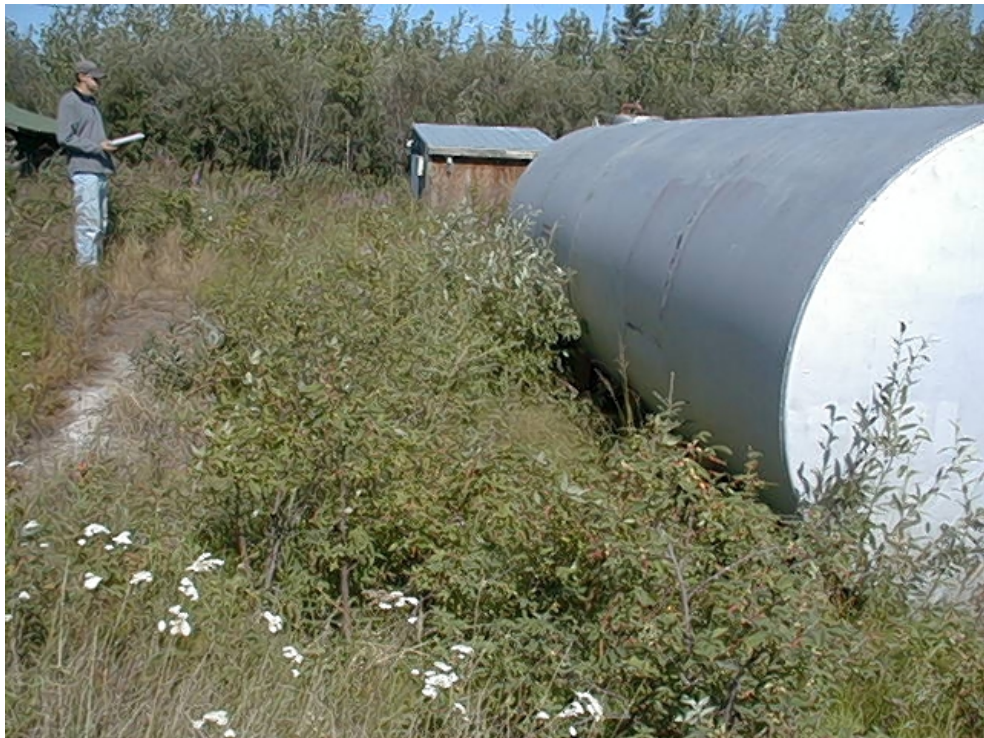
Photo # 25: 10,000 gallon abandoned storage tank.

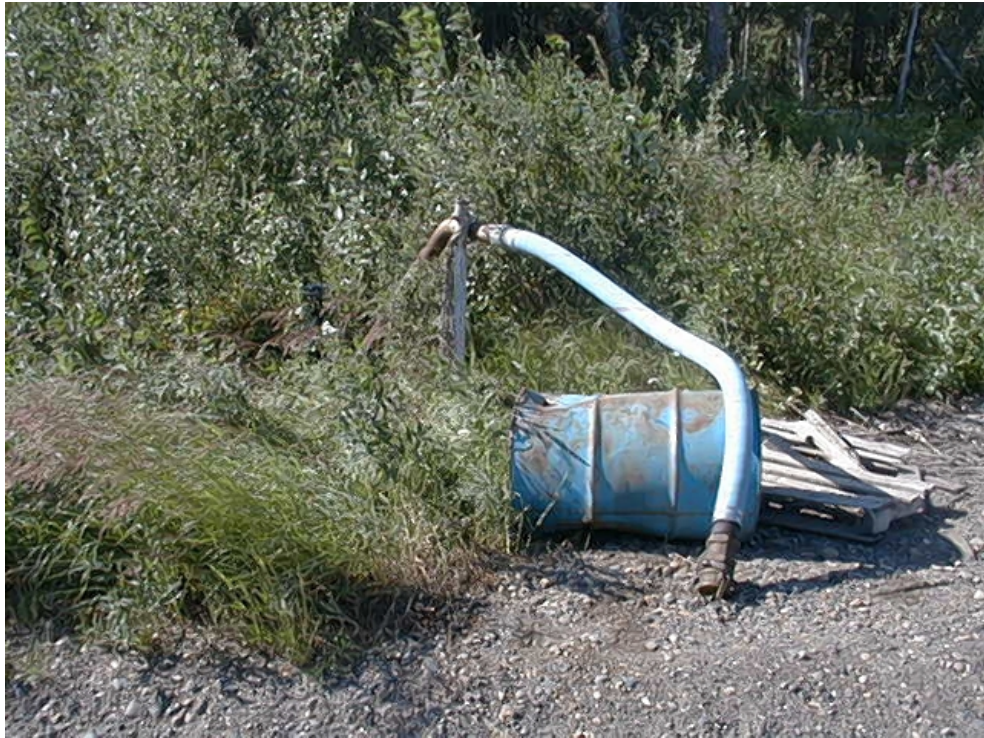
Photo # 15: Pipeline from the Airport to the Generator Building.

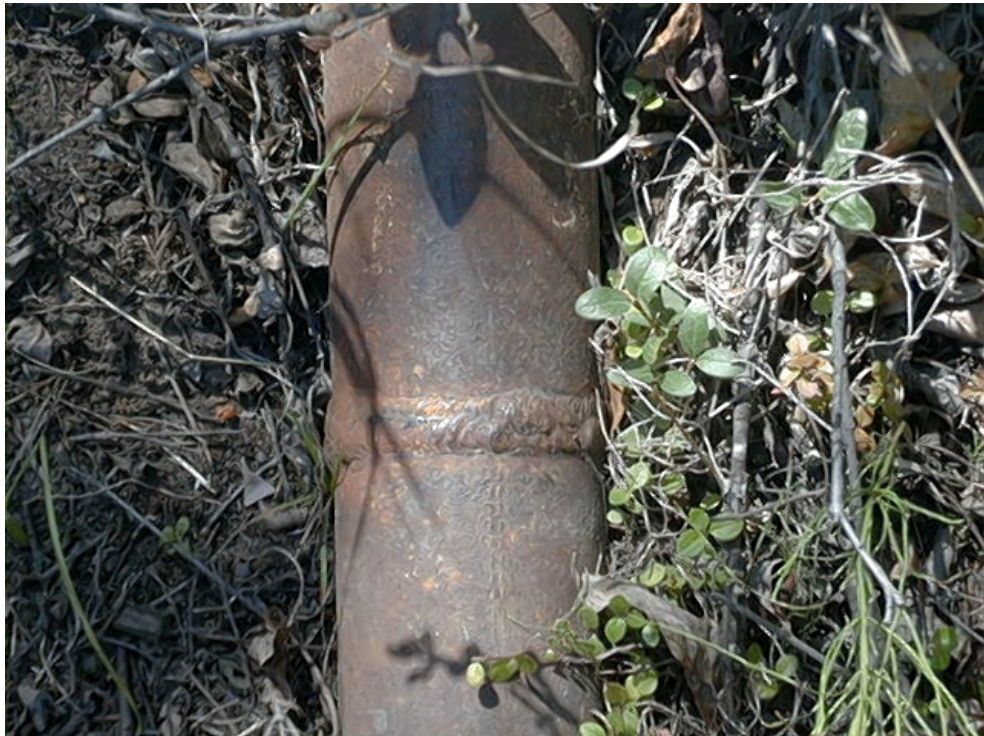
Photo # 17: Welded joint in 4" pipe of pipeline.

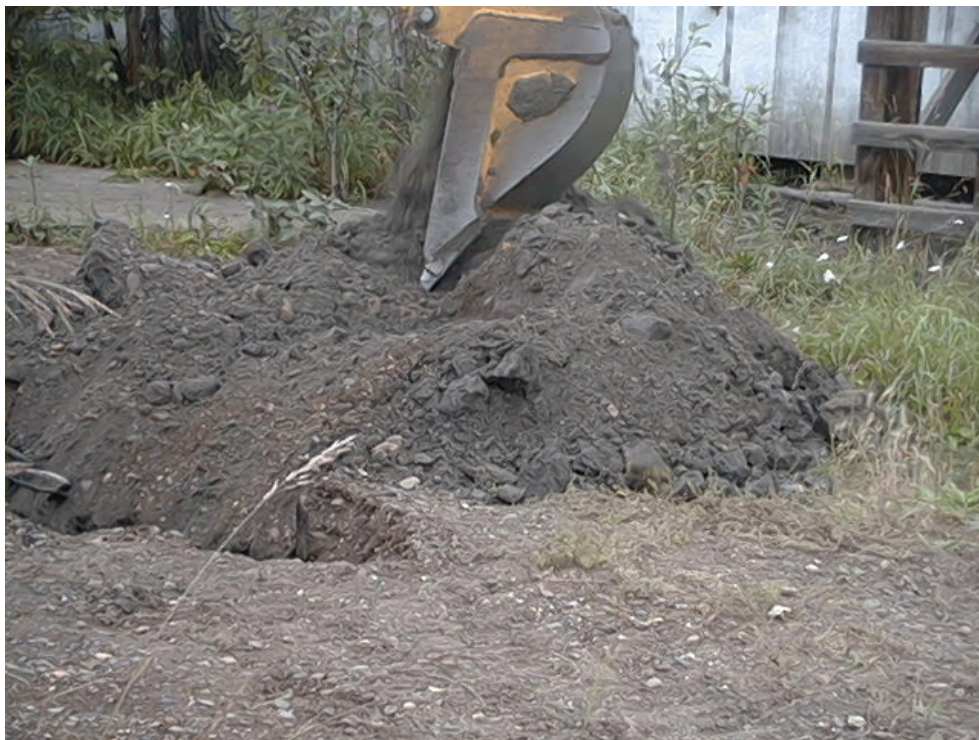
Visible surface staining was identified underneath and on the northeastern edge of the old generator building during this site assessment.

Photo # 112: Stained soil from sample test pit OPT1.

The close proximity of this site to the school tank farm effectively makes it part of the same contamination area. Recommendations for this site are identical to the recommendations made for the Cruikshank School Tank Farm.

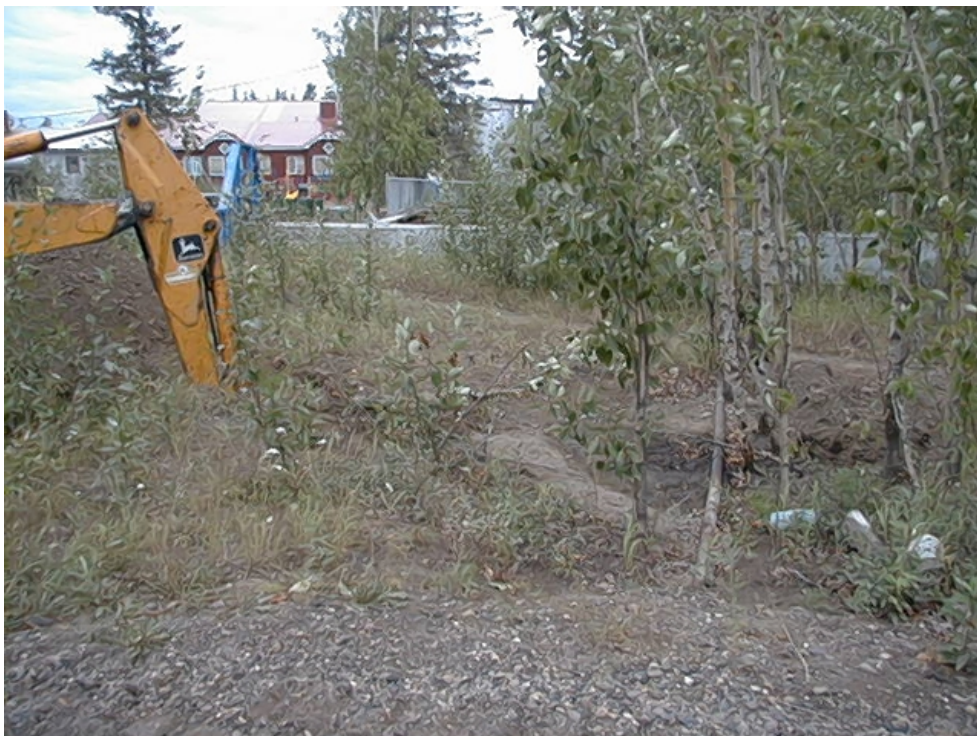
Photo # 108: No sample collected (obvious contamination).
